COMPARISON OF POST-
EXCAVATION BANK SLOPE
SAMPLES TO HISTORICAL DATA

MEMORANDUM

To:	Karen Keeley, Remedial Project Manager
From:	Eric Pilcher, Field Supervisor
Date:	July 26, 2012
Subject:	Slip 4 EAA, Post-Excavation Sampling
Project No.:	A0006-0014L

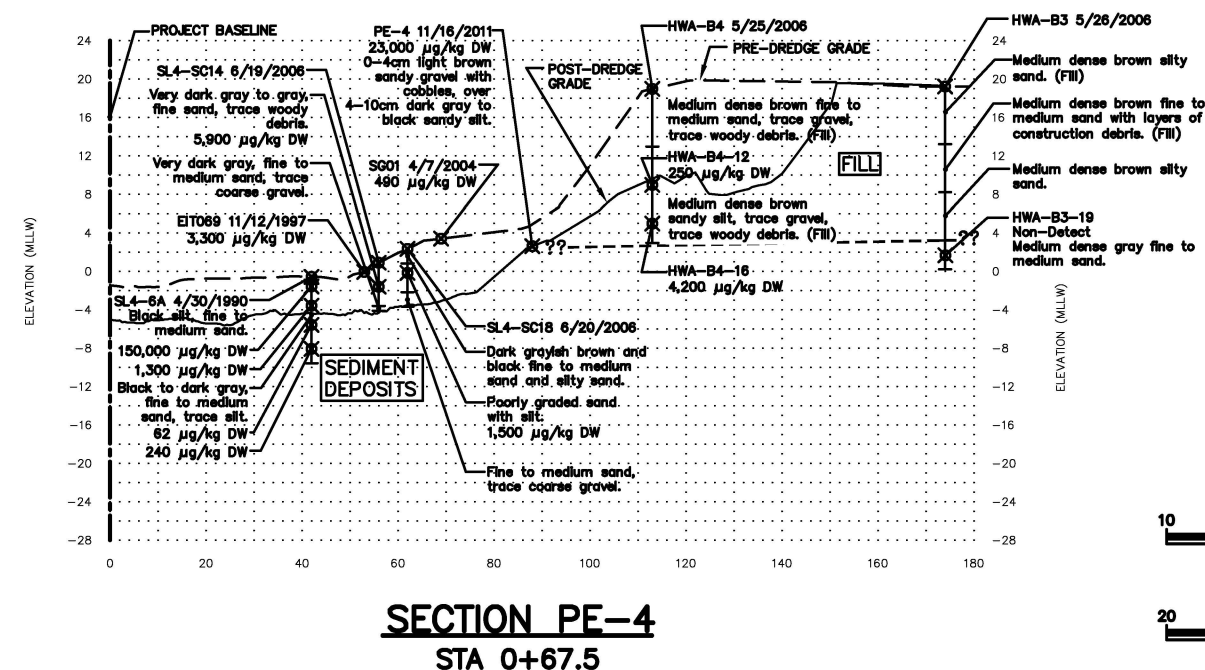
Figure 2.
Stratigraphy and PCB Concentrations at
Sample Locations PE-2 and PE-4
Slip 4 Removal Action

NOTES:
1. Assumed stratigraphic contacts are approximate interpretations, based on limited information, as shown.

PCBs in historical surface and subsurface sediments near Stations PE-2 and PE-4 ranged from 8.9J µg/kg to 150,000 µg/kg dry weight (Table 1). PCBs in two historical subsurface samples from Station SLP4-08-01 (Landau 2008) had PCB concentrations similar to those at Stations PE-2 and PE-4 (i.e., 28,000 µg/kg at 1.0–1.5 ft below the mudline and 37,000 µg/kg at 1.5–2.0 ft below the mudline). Station SLP4-08-01 is approximately 57 ft southeast of Station PE-2 and approximately 107 ft south-southeast of Station PE-4. The maximum historical sediment PCB concentration was observed at Station SL4-6A (150,000 µg/kg), located approximately 99 ft from PE-2, and 53 ft from PE-4. The cross sections shown on Figure 2 include PCB results for nearby sediment samples.

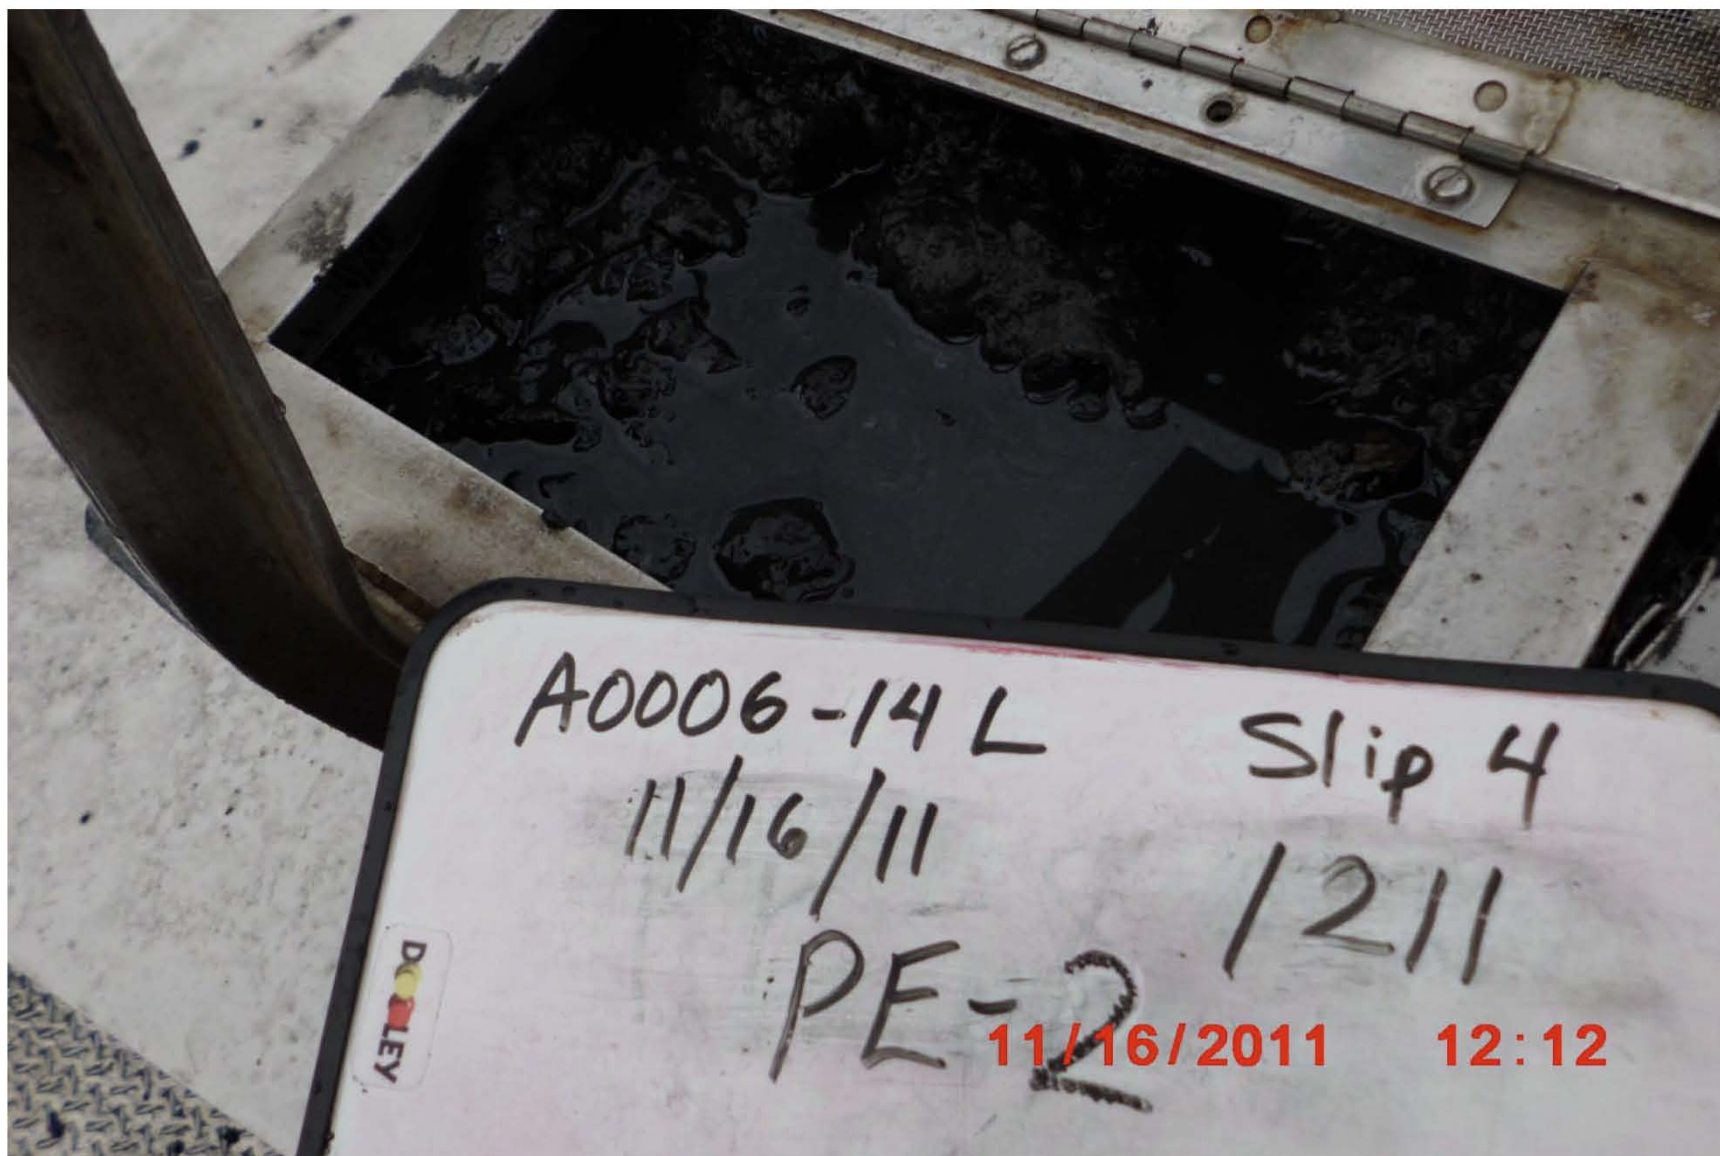
Samples from Stations PE-2 and PE-4 both appeared to consist of “natural” sediment deposits, although there was some fill material noted on the surface of the Station PE-4 sample (Figure 3). Sample PE-2 was described as dark grey to black silt with organics (leaf litter) with a slight rainbow sheen and hydrocarbon odor. Sample PE-4 was described as 4 cm of light brown sandy gravel with cobbles (assumed sloughed fill material from adjacent slope), overlying 6 cm of dark grey to black sandy silt with a strong sheen and hydrocarbon odor. Photos of the sediment surfaces at Stations PE-2 and PE-4 are provided in Figures 4 and 5, respectively.

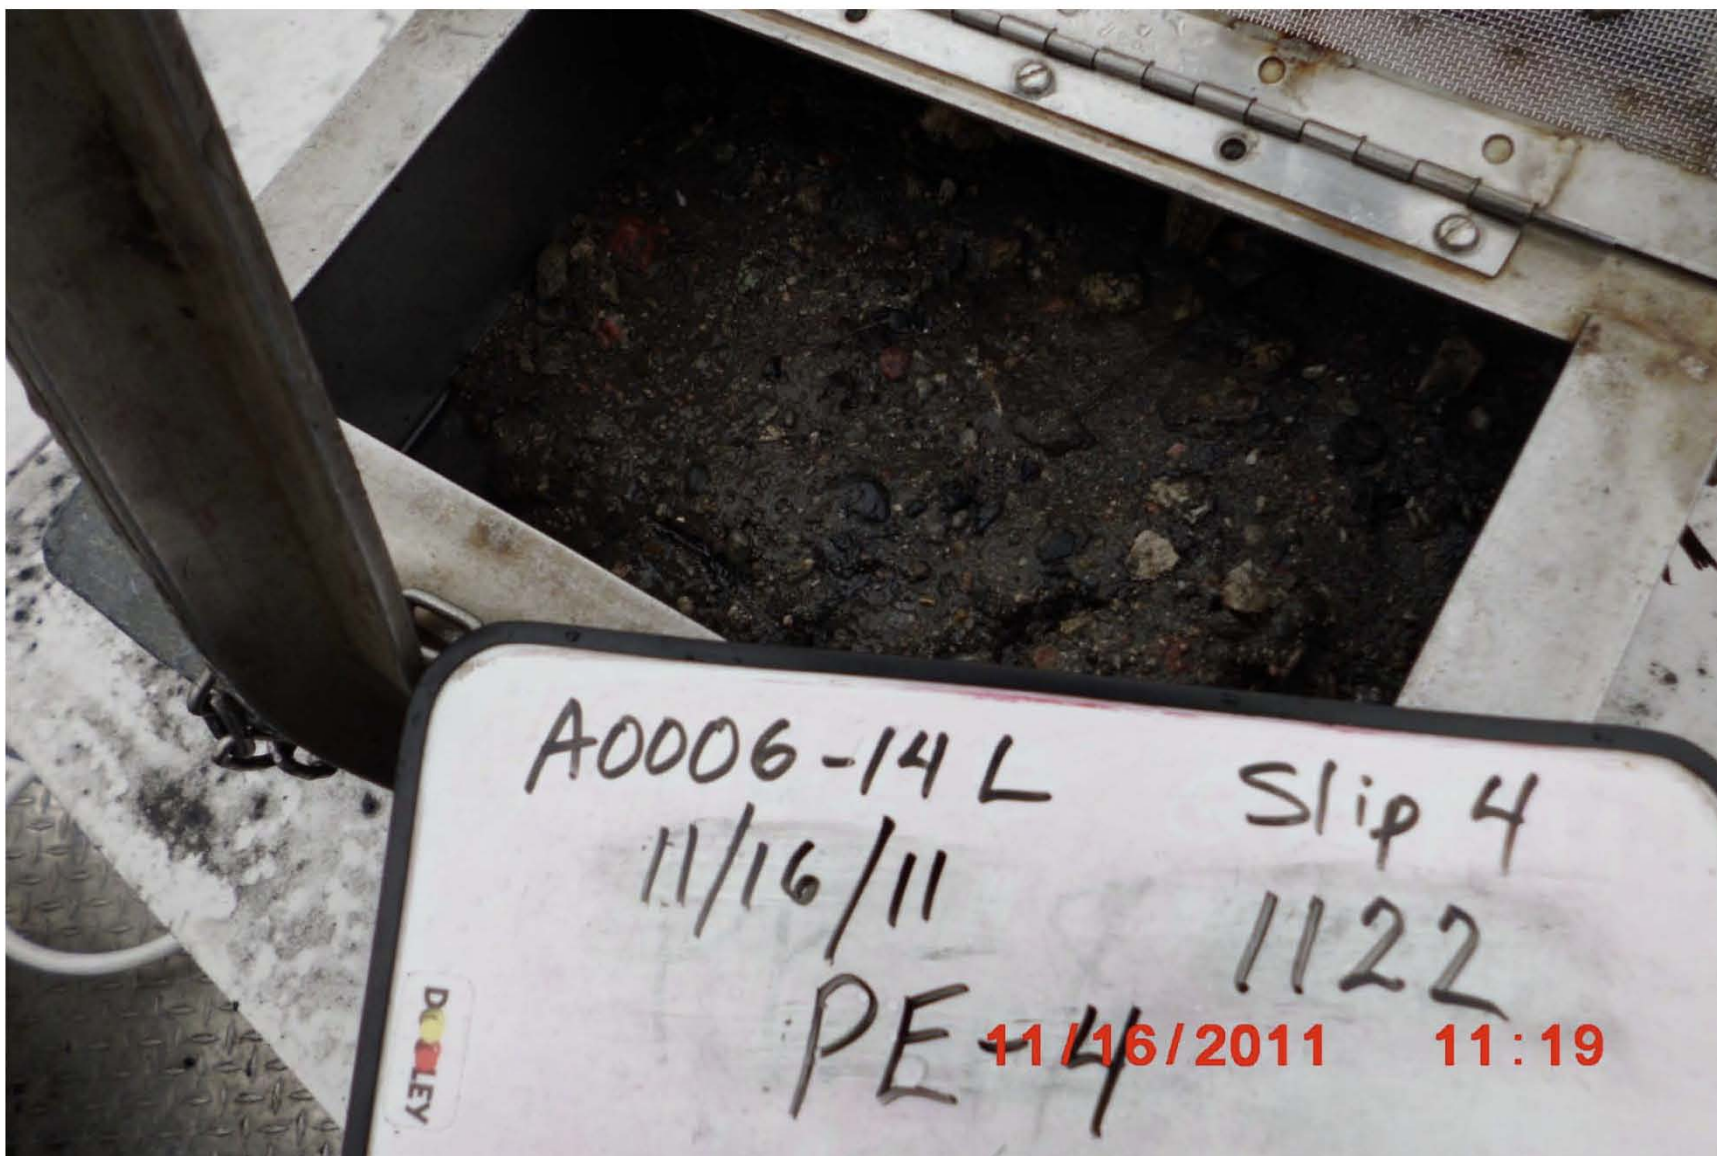
Post-excavation total PCB concentrations at Stations PE-2 and PE-4 were 31,000 and 23,000 µg/kg dry weight, respectively, with total organic carbon (TOC) contents of 4.86 and 1.71 percent, respectively. The somewhat lower TOC content at PE-4 may be attributable to sloughed bank fill material observed near the surface of this sample.

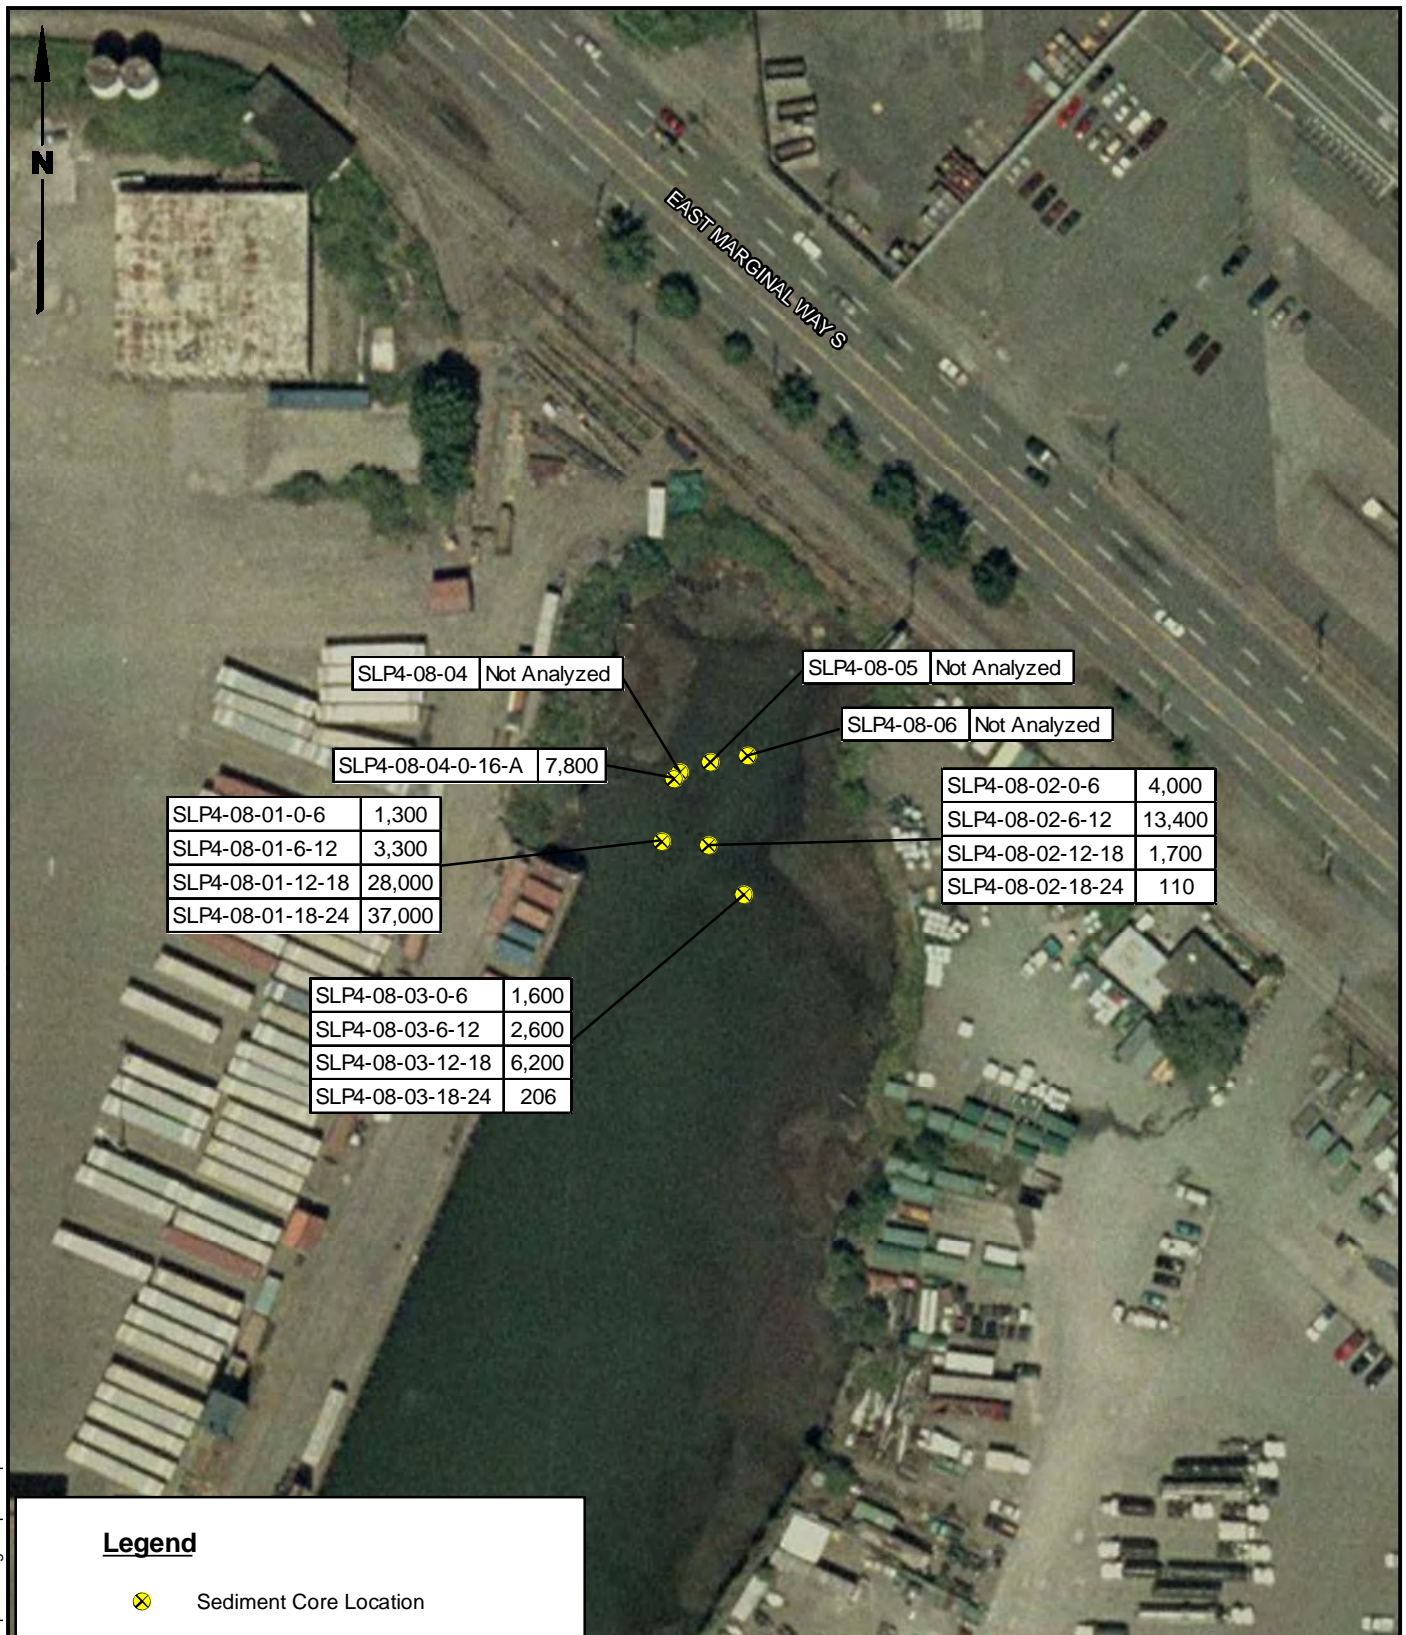
SLP4-08-01

SAMPLE DATA			SEDIMENT DESCRIPTION		
Depth (ft)	In situ Sample Interval (ft)	Test Data	Graphic Symbol	USCS Symbol	Coring Method: <u>Hammer Core</u>
					Elevation (ft): <u> </u>

Coring Completed 09/19/08
Core logged and sampled by SM on 9/19/2008
Total Penetration = 2.2 ft.

Landau (2008) collected a number of sediment cores near the head of Slip 4 in 2008. Review of Landau’s core logs (Attachment 1) indicates near-surface sediments were predominantly black silt and all had a petroleum odor. These are the same characteristics as observed at Station PE-2 and from 4–10 cm at Station PE-4.
